Journal of  
*Ecotechnology*  
Vol.3 No 2      December 2007

# Journal of Ecotechnology

Volume 3, Number 2

Conservation on Reservoir of Buffer Zone and Impounding Zone in Taiwan Yueh-Chi Kuan, Kuang-Chih Chang	13
Role of Stream Restoration on In-Stream Water Quality in An Urban Watershed– A Case Study Ariamalar Selvakumar, Anthony N. Tafuri, Richard Field	23
Ecological Campus Development at the National Taipei University of Technology Jen-Hui Tsai, Mei-Chu Kang	38

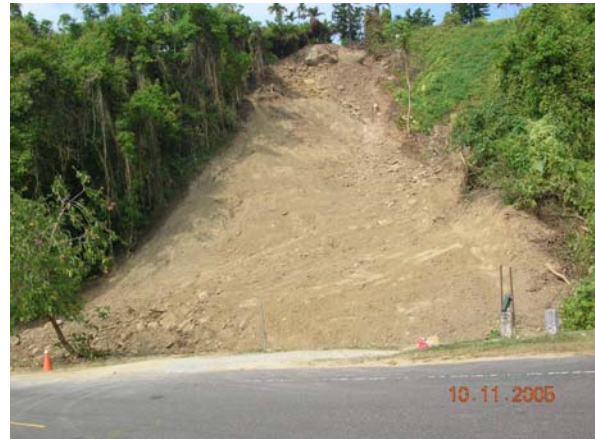
**Figure 2.** Before restoration

A typical example of the use of "soft" engineering approach is described below, which is the restoration project for landslide areas at the Tseng-Wen Reservoir in Southern Taiwan. The total project cost was NT\$8.13 million. Main features of the restoration work included the construction of intercepting ditches to divert runoff from the landslide areas and the use of ecological engineering methods to stabilize the bare land and planting by hydro-seeding.

Figures 2-5 illustrate the site during various phases of the restoration project.

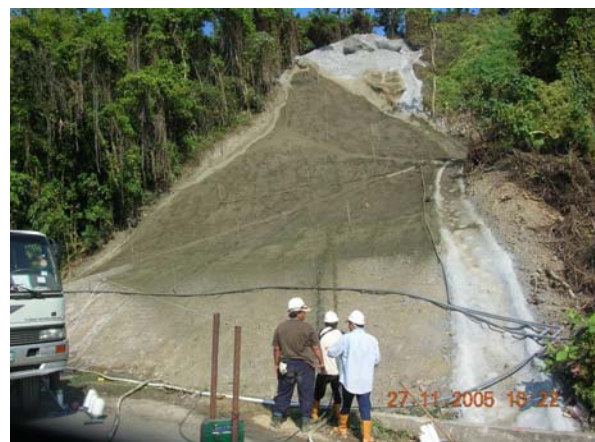
**Figure 3.** During planting

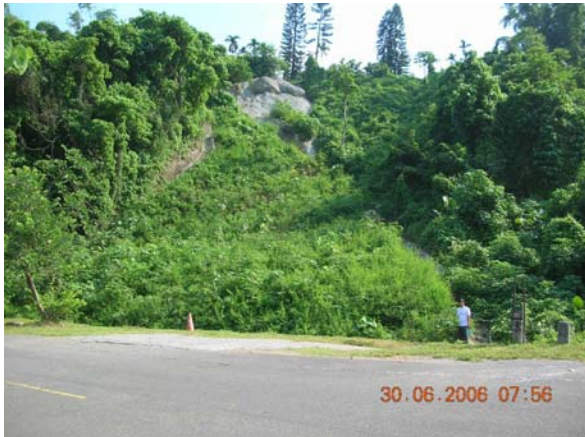
**Figure 5.** Six months after planting.

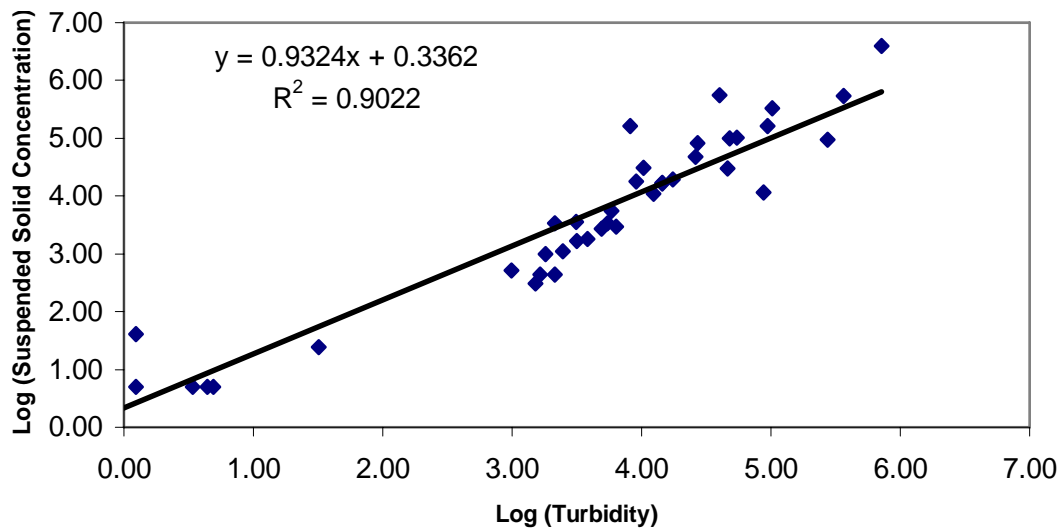
**Figure 3** Correlation between turbidity and suspended sediment concentrations.

Based on USGS data, plots were developed for turbidity vs. suspended sediment concentration (SSC) and E. coli (Figures 3 and 4, respectively). A correlation appears to exist

between turbidity and SSC (R<sup>2</sup> = 0.90). Similarly, a correlation is apparent between turbidity and E. coli, but is not as strong as with suspended sediment (R<sup>2</sup> = 0.58).

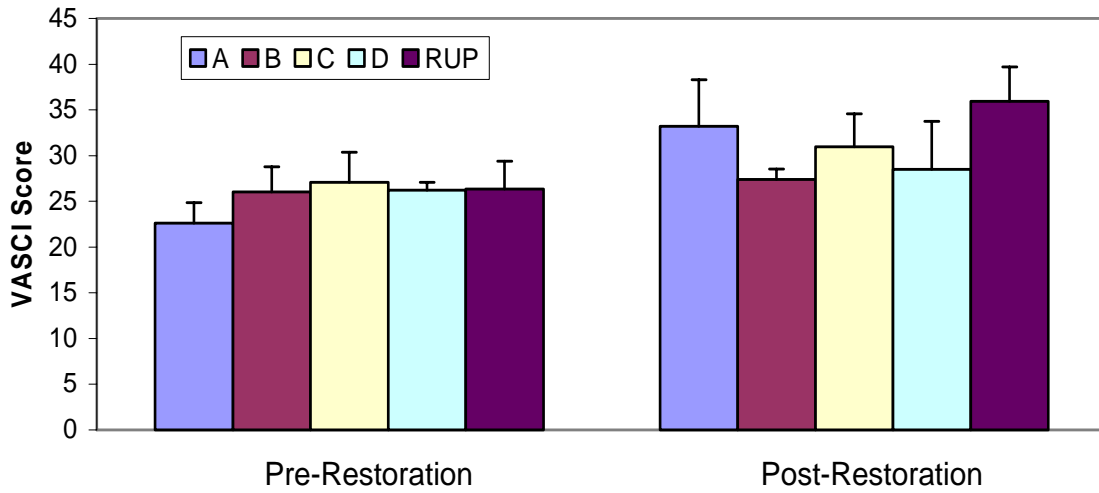
**Figure 5** Virginia Stream Condition Index (VASCI) Scores for before and after the Accotink Creek stream restoration.

agement strategy. Control site VASCI scores following restoration are intended to provide an attainable goal for sites B, C, and D within the current restoration reach. Parity between all

sites of VASCI scores above 36 during the same season of the year would indicate a successful restoration for benthic macroinvertebrate habitat.

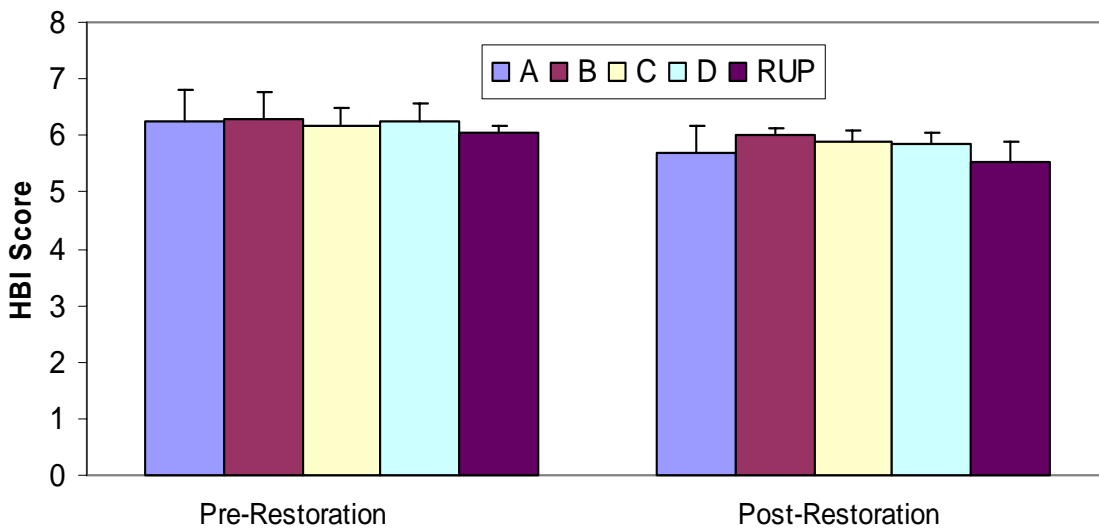
**Figure 6** Hilsenhoff Biotic Index (HBI) Scores for before and after the Accotink Creek stream restoration.

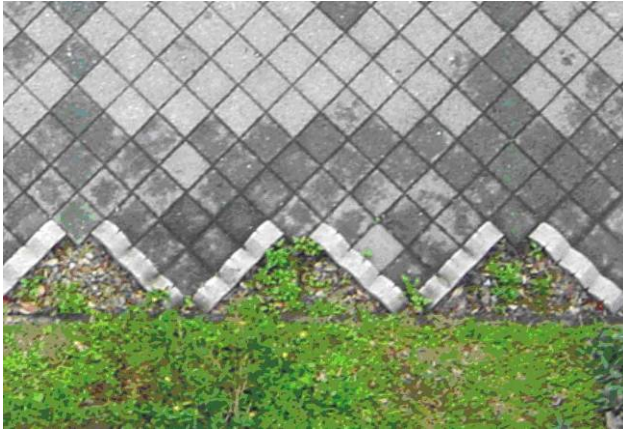
**Figure.7** Permeable Pavement in Front of the Design Hall

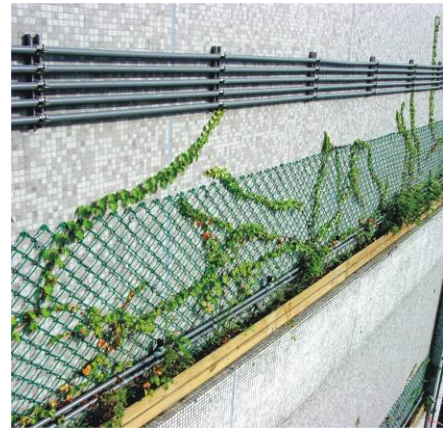
**Figure.8** Design Hall Wall Revegetation

The concept of “Wall Revegetation” (Figure.8) is: “Utilize the grey water emitted from the Design Hall to water the vines of the exterior wall in order to form a green fence.” “Campus Waterscape” (Figure.11) was completed in 2000 to fulfill a dream. It influenced not just humans. Nightingales and white egrets were seen on the sidewalks of Zhongxiao East Road nearby. It has connected the eco-reservoir with the outside world making regional ecology more enriched and diversified.

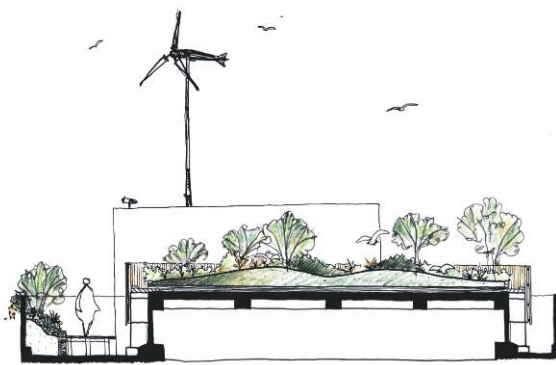
**Figure.9** Eco-Balcony Section, Illustrated

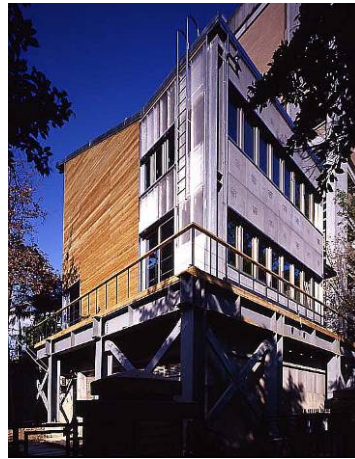
**Figure.12** View of Eco-Green Architecture

**Figure.13** Night View of Eco-Green Architecture

**Figure.14** Section of Relationship of Eco-Green Architecture and Surrounding Eco-Environment, Illustrated

“Eco-Green Architecture” (Figure.12, 13 and 14) incorporated design, practice and international cooperation and completed integration of ecology and humanities. In accordance with Taiwan’s hot and humid climate, it utilized environmental conditions to plan a comfortable indoor environment that is in harmony with nature and energy-effective. Students were allowed to participate in the planning and construction of the project as a way of realizing the “learning in doing” concept of architecture education. They also acquired the idea of eco-green architecture through this project. The Eco-Green Architecture is situated between the Campus Waterscape and the Eco-Reservoir to demonstrate the fact that ecology and humanities are one. Ministry of Education encouraged NTUT to apply the concept behind this building to the new Education Research Building of which the ground-breaking was about to take place.

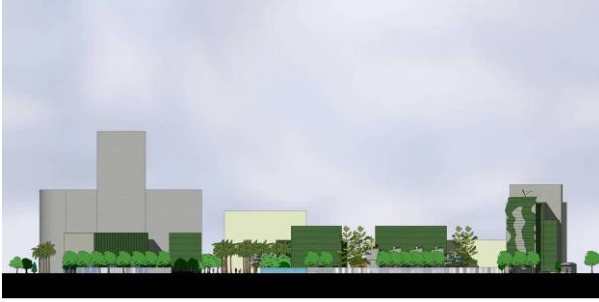
**Figure.20** NTUT Xinsheng South Road 3D Eco-Revegetation, Illustrated

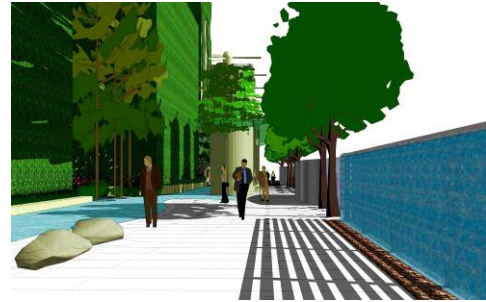
**Figure.21** Waterscape of NTUT Xinsheng South Road Eco-Corridor, Illustrated

verted the wind power from the depressurizing hole of MRT into regenerated energy that activates the waterscape as a public artwork to indicate arrival of the train. This technological and ecological water-corridor concept integrates water resource environment, public arts and technology. Through observing the street that serves as the urban-campus interface, it looked for traces of urban living esthetics in NTUT's eco-campus planning and became the spokesman for eco-city. This project has completed an urban water environment that carries the image of technology, ecology and humanities (Figure.19, 20 & 21). It also attempts to connect MRT with Huashan Culture Park, whose completion in the future can be expected to set off this district for another round of development. The campus display was completed on November 2, 2007. Currently NTUT is seeking construction funding from government agencies.
